Technical Memorandum 33-615

*Mariner 9 Solar Array Design, Manufacture,
and Performance*

E. A. Sequeira

**JET PROPULSION LABORATORY
CALIFORNIA INSTITUTE OF TECHNOLOGY
PASADENA, CALIFORNIA**

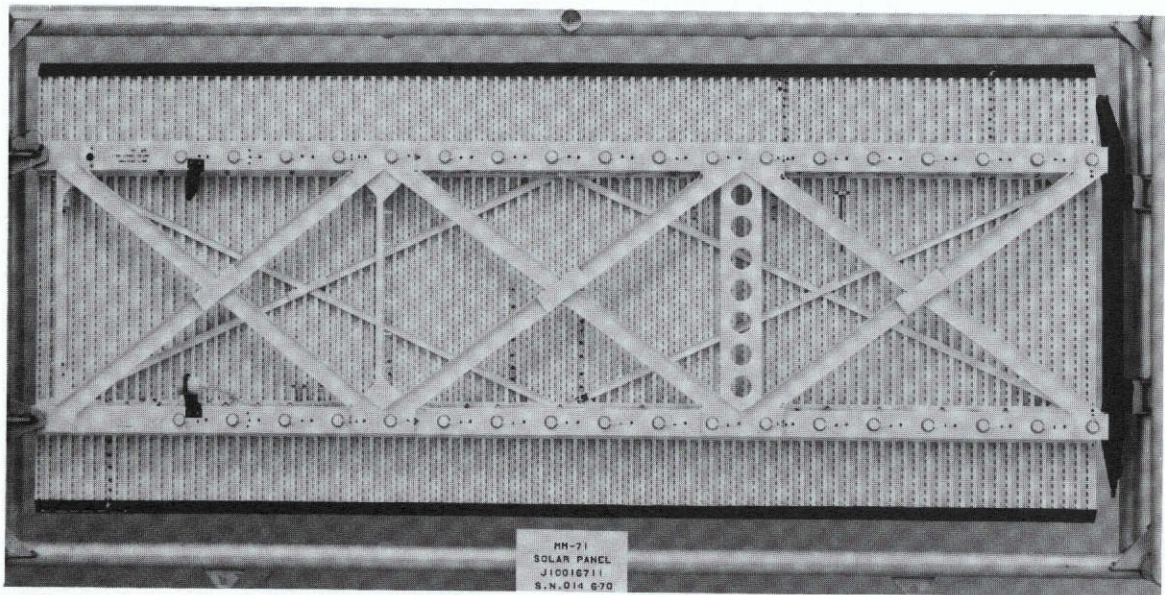
Fig. 1. MM-71 Solar Panel

The Mariner 9 solar panels were similar in construction to Mariner 6 and 7 panels except for a minor modification of attachment hardware to accommodate extended outriggers that were required to extend the solar panels further from the spacecraft bus. Maintaining the basic Mariner 6 and 7 design permitted the Mariner '71 program to utilize solar array spare hardware remaining from the Mariner '69 program. A total of seven new solar panel substrates were fabricated by Zero Manufacturing Company of Los Angeles, California. Two Mariner 6 and 7 residual panels were refurbished and requalified for the Mariner 9 program. A photograph of the panel structure is shown in Fig. 1. The substrate consists of (0.127 mm) aluminum alloy facing reinforced with lateral (0.0762 mm) corrugations which provide rigidity across the panel. Two spar assemblies extended across the length of the panel along with cross members, which was required for increased torsional rigidity, make up the main structural support of the units. The face sheet and the corrugations are bonded to the spar assembly with Shell Epon 913 epoxy adhesive. The spar beams supported the zener diodes and provided the heat sink necessary for diode temperature dissipation. During launch the four panels of the Mariner 9 solar array are tip-latched together as shown in Fig. 2. After injection into space, the latches are released through pyrotechnic activation and the panels are deployed through a deployment damper mechanism located on the panel outrigger assembly.

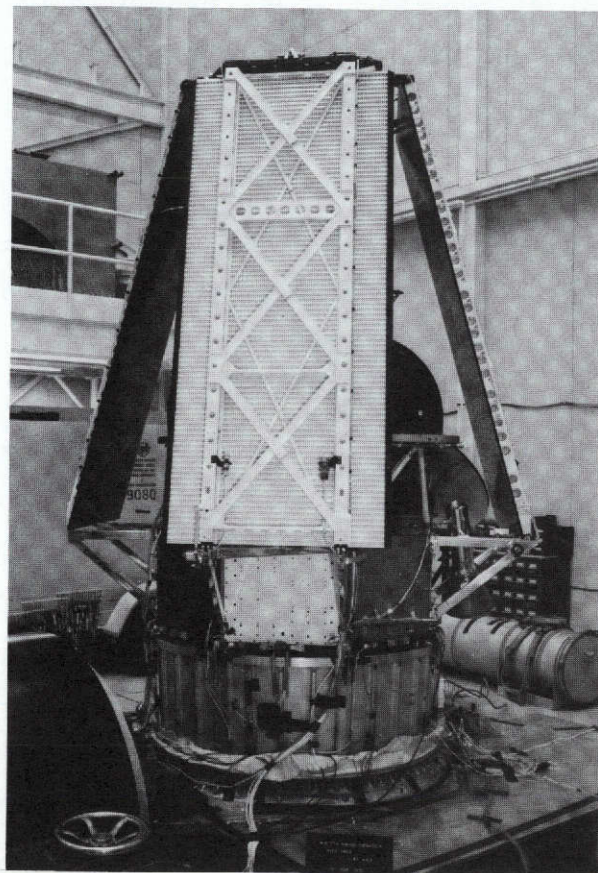
Fig. 2. Spacecraft With Solar Panels Tip-Latched

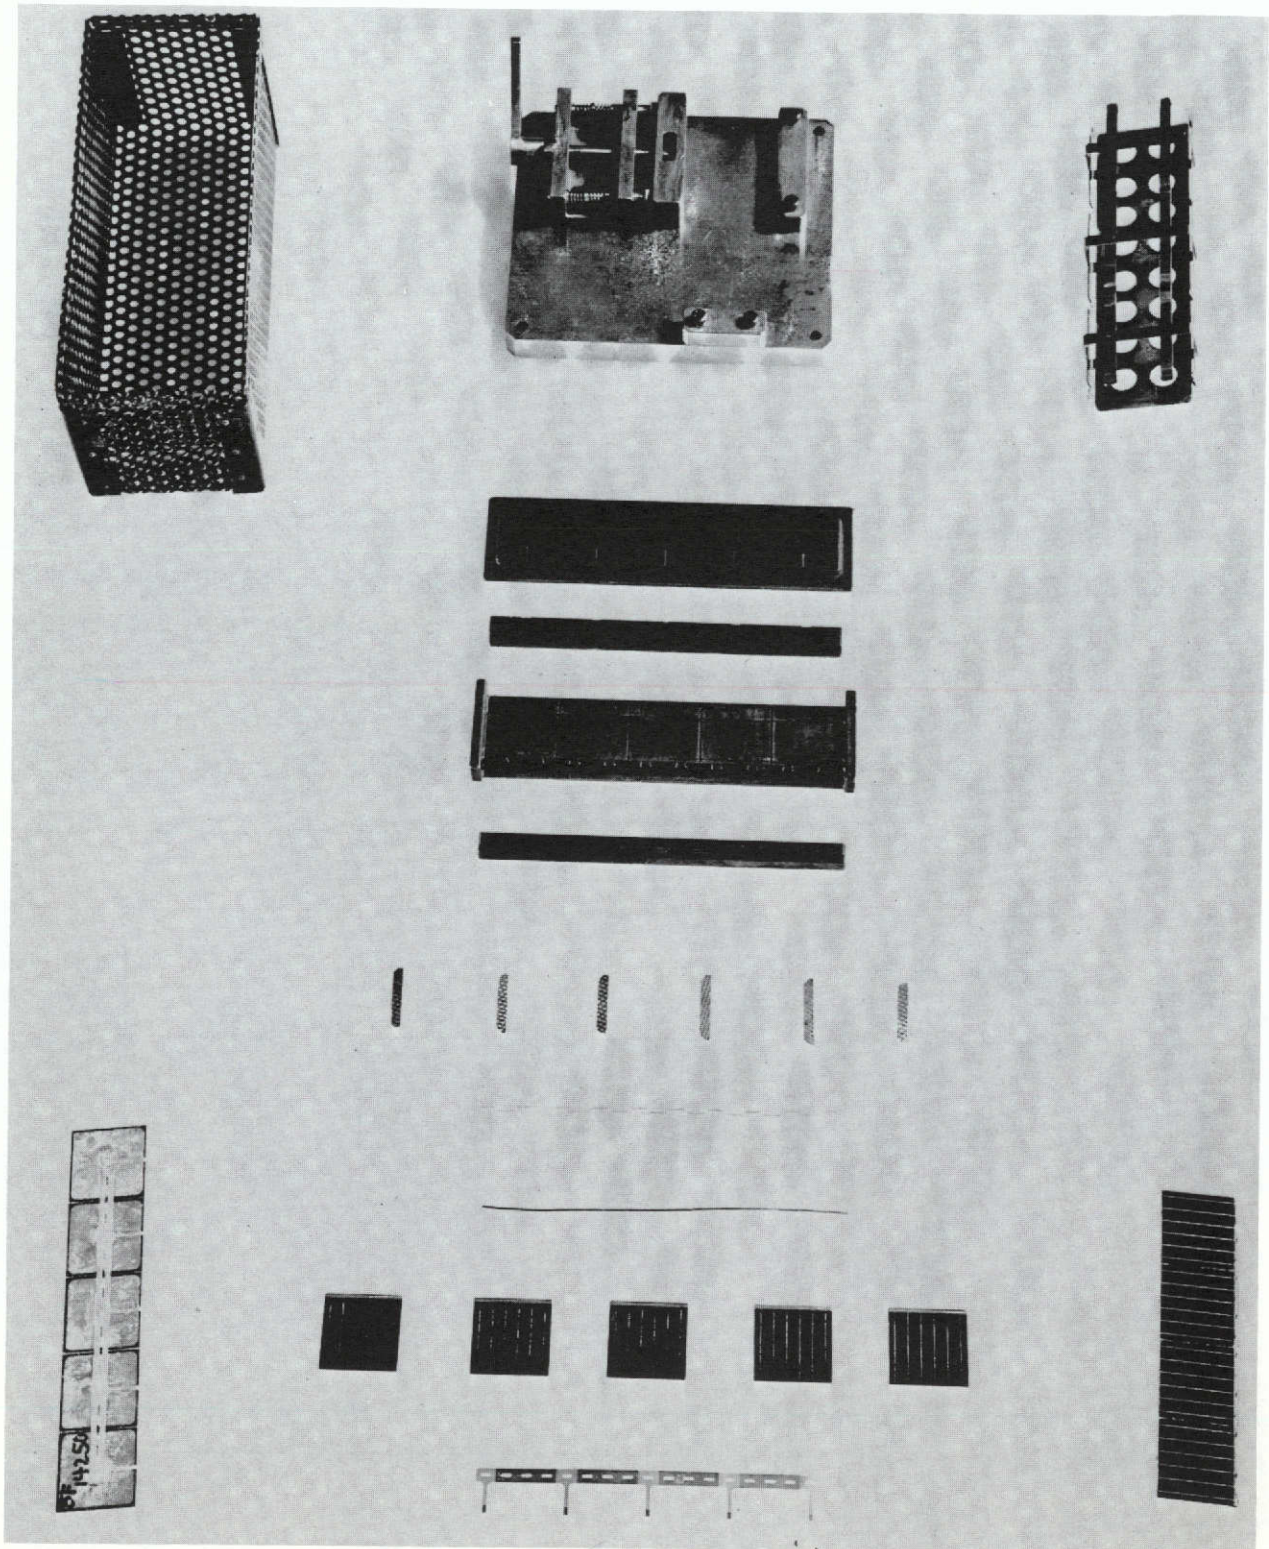
Fig. 3. Soldering Fixture and Submodule Assembly

2. Solar array submodules. A Mariner 9 solar array is an assembly of 4 or 5 matched solar cells electrically interconnected in parallel by 0.0762-mm tin plated kovar bus bars. The submodule design of a Mariner 9 solar array was developed during the Mariner 6 and 7 spacecraft program. This design had been developed to optimize the following array parameters: reliability, cost, ease of fabrication and the utilization of the maximum available area of the solar panel. Four and five-cell submodules were fabricated for the program. Interconnection of cells and bus bars was accomplished through soldering, using a tunnel oven soldering process. The cells and the kovar bus bars were assembled in a soldering fixture and the unit was processed through a tunnel oven which heated the fixture to temperatures above the melting point of solder. The soldering fixture and the resulting submodule assembly is shown in Fig. 3.

One of the more significant differences between the Mariner 9 and the previous Mariner program was the redesign of the soldering fixture which was greatly improved and simplified. The following improvements were incorporated into the Mariner 9 tunnel oven submodule soldering fixture design:

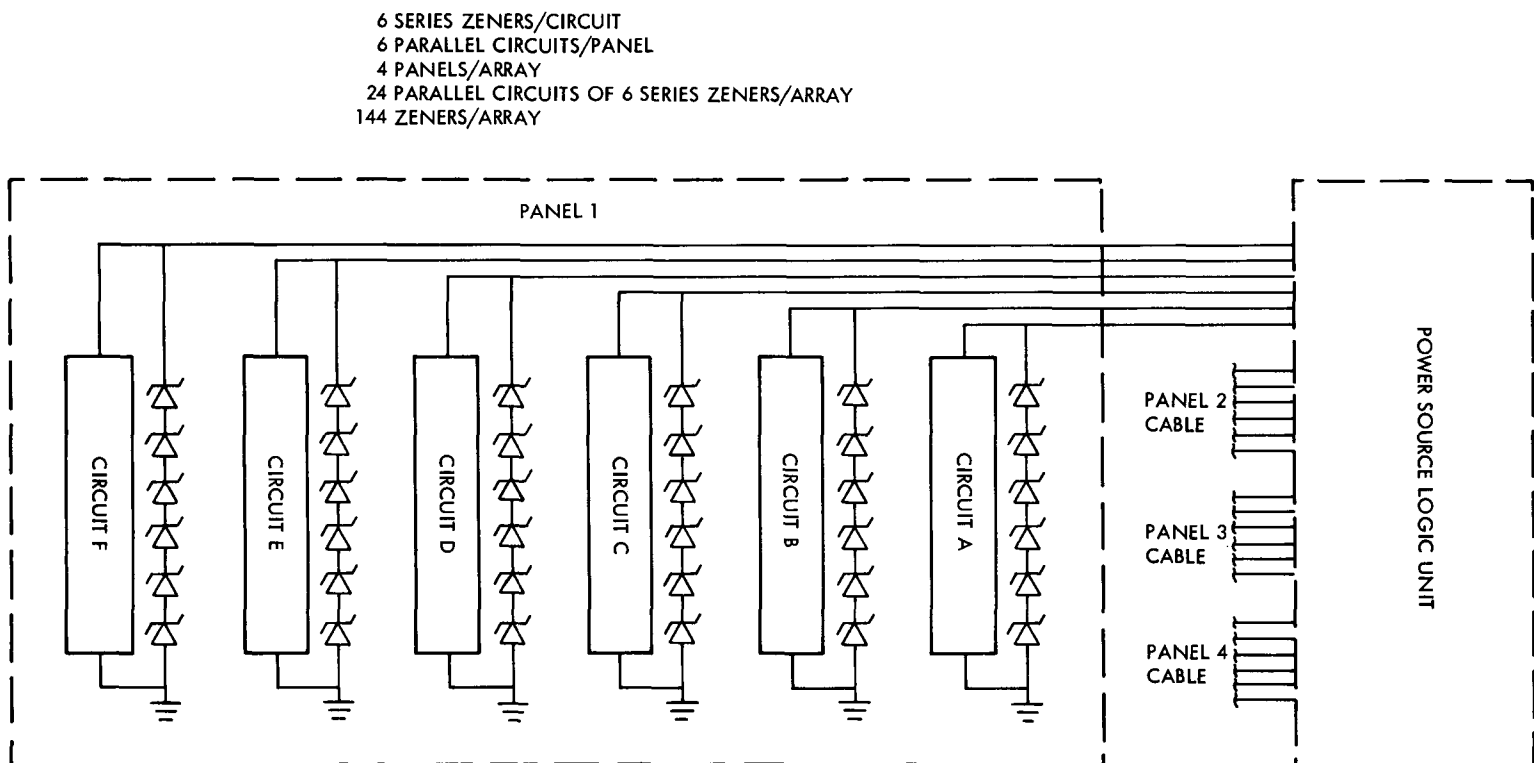
Fig. 5. Mariner 9 Solar Array-Zener Diodes Schematic

The flight configuration of the Mariner 9 solar array shunt regulator required six Dickson DZ30808G zener diodes connected in series for each electrical section of a panel as shown in Fig. 5. Since there are six parallel sections per panel and four panels per array, there are a total of twenty-four parallel circuits of six series zeners per circuit or a total of 144 zeners per array. The diodes are mounted and torqued to the underside of the panel box beam spars that provide the heat sink for diode temperature control. The diodes are screened to provide a rated value of 8.25 volts plus or minus 2 percent at one ampere and 90°C stud temperature. A series string of 6 of these zeners was utilized to limit the voltage output of each panel electrical section to less than 51 volts. The thermal and electrical characteristics of each six zener diode series string, developed using composite I-V characteristics of the twenty-four parallel circuits of zeners as a function of spar temperature at one ampere, are seen to be 0.0213 volts/°C. Thermal analysis of the Mariner 9 solar panel design shunt has shown that the spar temperature (where the zener diodes are mounted) would be lower than the solar cell temperature by approximately 15 degrees and that the difference will vary as a function of solar intensity incident on the solar cells. This relationship is presented in Fig. 6.

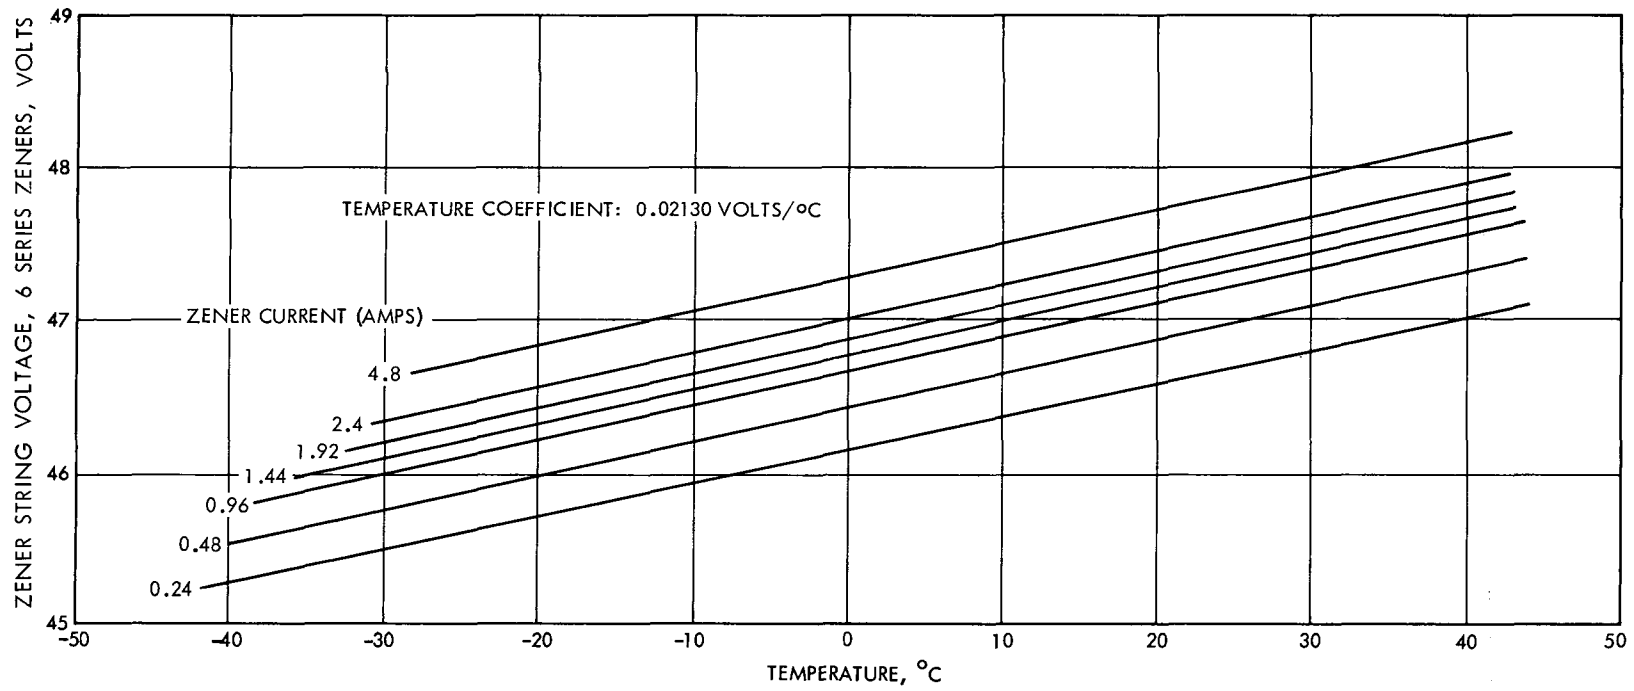
Fig. 6. Zener Diode String Voltage as a Function of Spar Temperature for Different Zener Currents

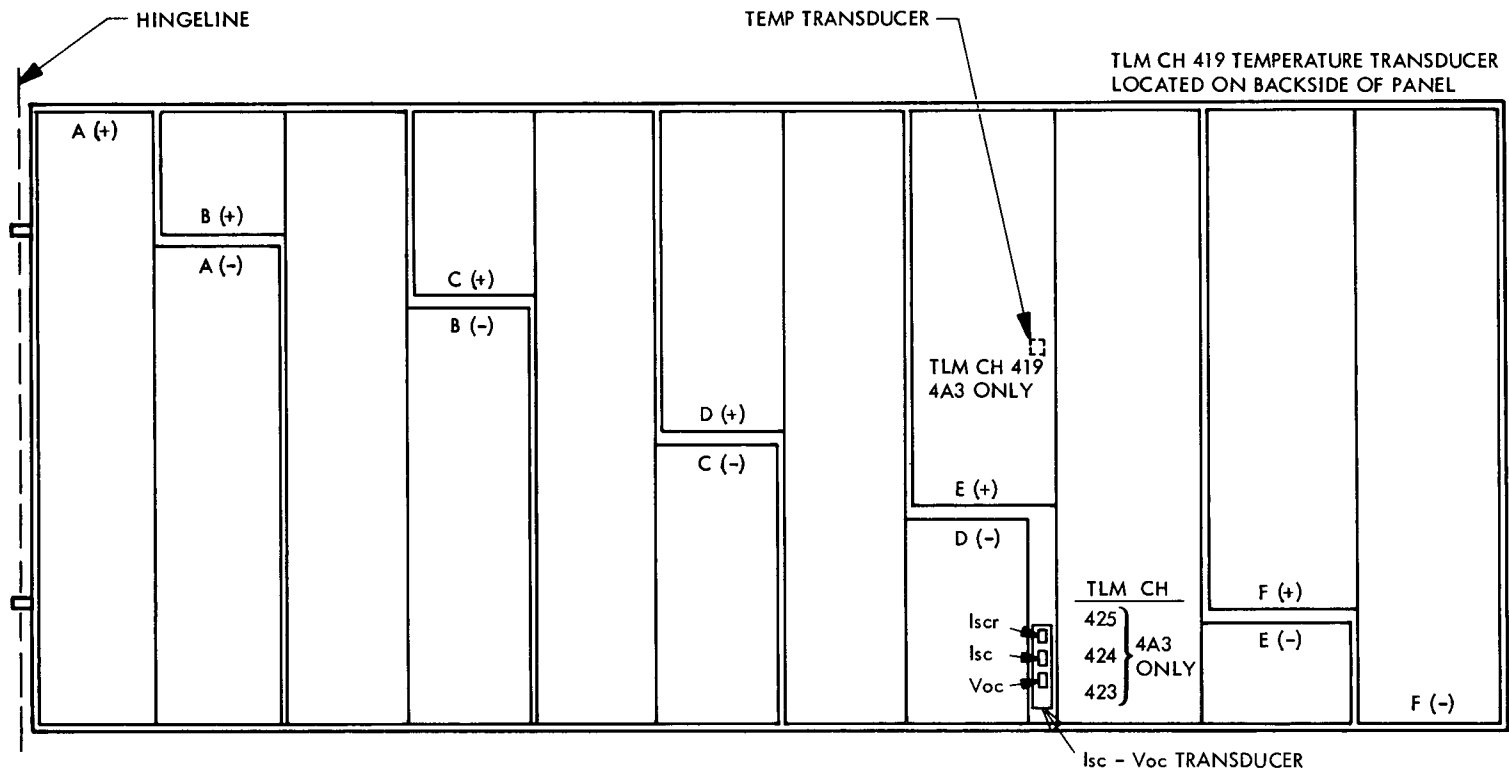
Fig. 8. Locations of Isc-Voc and Temperature Transducer on Mariner 9 Solar Panel

- (1) Temperature transducer. Transonic T-4242 transducer located on the backside of the plus Y solar panel provided information on the solar panel temperatures. The location of the transducer is shown in Fig. 8. Due to the similarity of Mariner 9 to Mariners 6 and 7 and the knowledge gained from Mariner 6 and 7 flight, the Mariner 9 solar array temperatures were predicted to within 2°C of actual flight data. Figure 9 shows predicted panel temperatures versus actual flight temperatures. The Mariner 7 solar panel had two transducers, one located on the inboard and the other on the outboard section of the panel. Measurements from the transducers indicated that the thermal excursion across the panel was approximately 2°C. It is assumed that Mariner 9 panels experienced the same type of temperature spread.

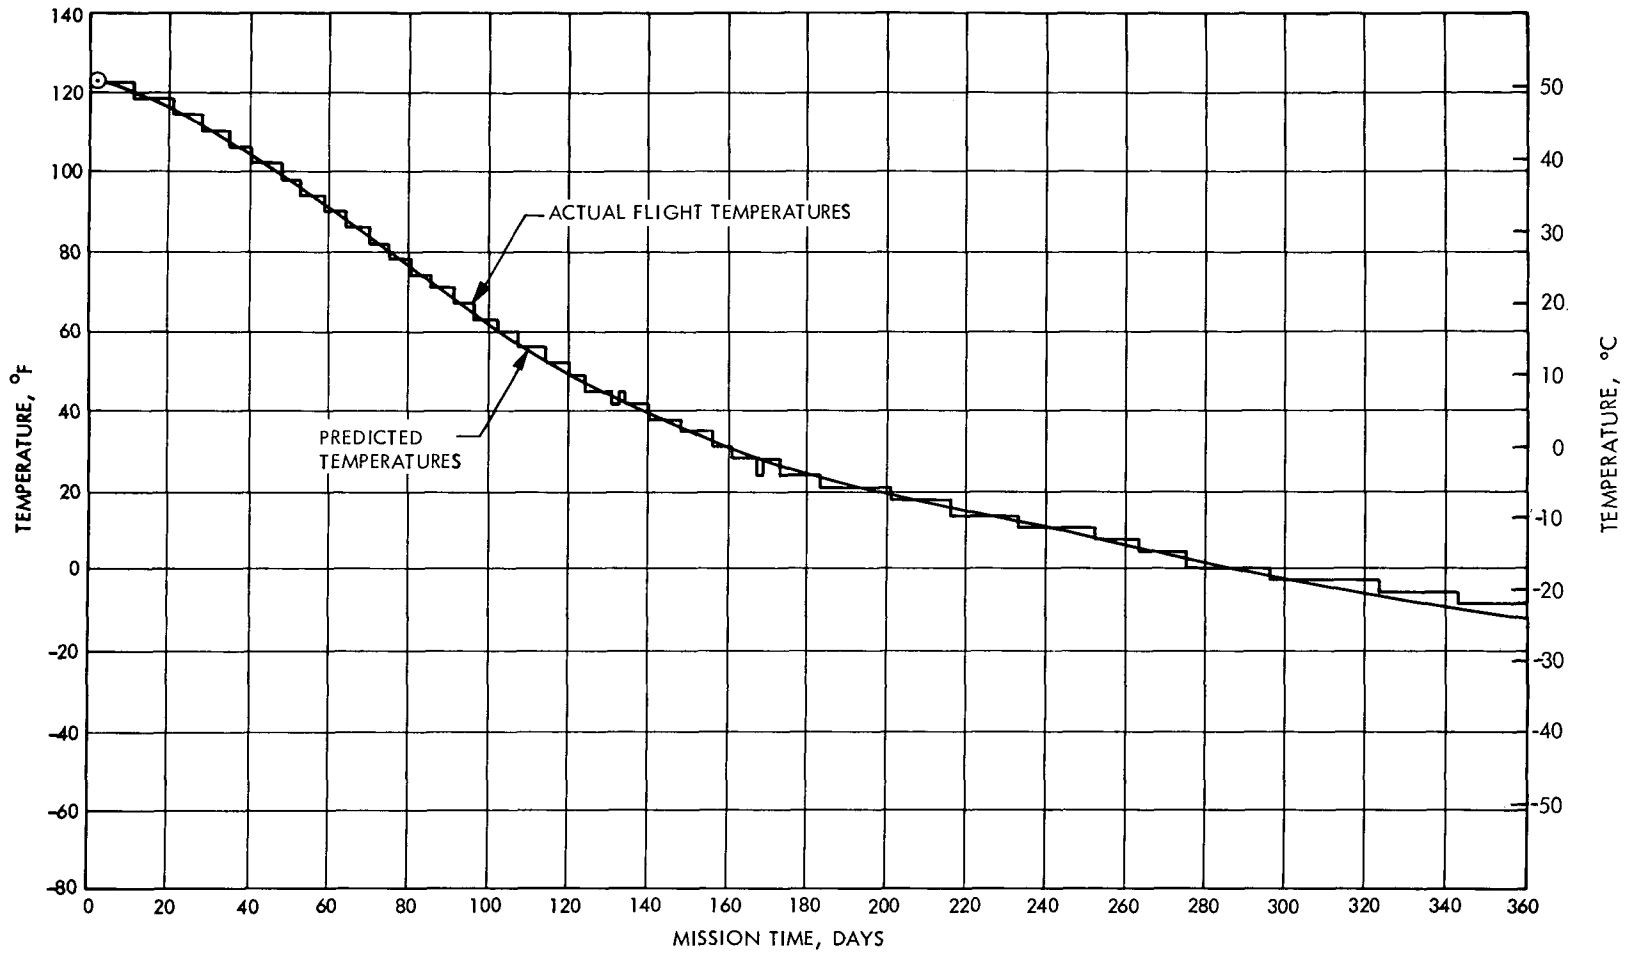
Fig. 9. Solar Panel Temperatures Recorded by Channel E419 Outboard Temperature Transducer

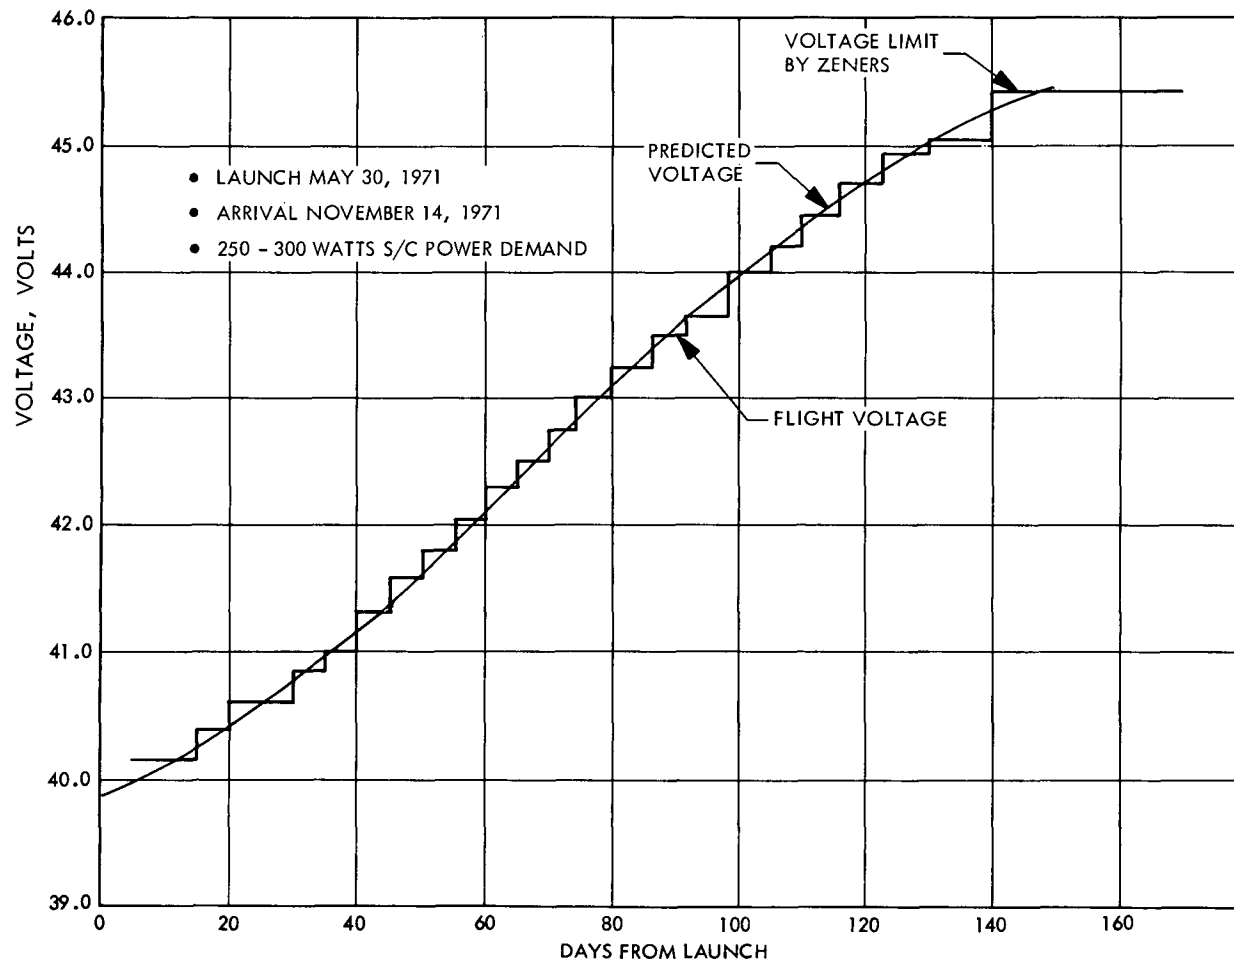
Fig. 18. Mariner 9 Solar Panel Performance Voltage Versus Time (PS and L, Channel 116)

45.4 volts, approximately 140 days from launch and continued to be so limited except during maneuvers and special events. Figure 18 shows array actual flight operating voltage from launch to Mars encounter. Zener limitation of solar array output prevents direction evaluation of operating characteristics; hence, after day 140, more reliance had to be placed on the Isc-Voc transducer in evaluating the array performance. On day 140 the transducer indicated that the array had degraded approximately 1.5 percent from launch. This measurement is believed to be outside the limit of telemetry data resolution and hence confidence in this value is not justified. This amount of change, however, corresponds very well with the performance of the Isc-Voc transducers flown on Mariners 6 and 7. Extrapolation of this data to encounter suggested that this array would be only 3.5 percent lower than the prelaunch predicted performance curves developed, assuming no solar flare degradation. It appeared the array had not experienced great space degradation and was performing close to its predicted characteristics. The Isc-Voc transducer and the solar array performance appeared to be tracking each other and future estimates of array performance would reflect the Isc-Voc operation. Based on flight transducer data, a revised encounter prediction was made 27 days before encounter. Shown in Fig. 19 is a plot of the I-V characteristics of the array assuming 3.5 percent current degradation. Plotted in Fig. 20 is the degradation experienced by the Isc-Voc transducer from launch through Test No. 2. It illustrated the 1.5 percent current degradation noted on day 140 and shows the 3.5 percent current degradation at encounter.

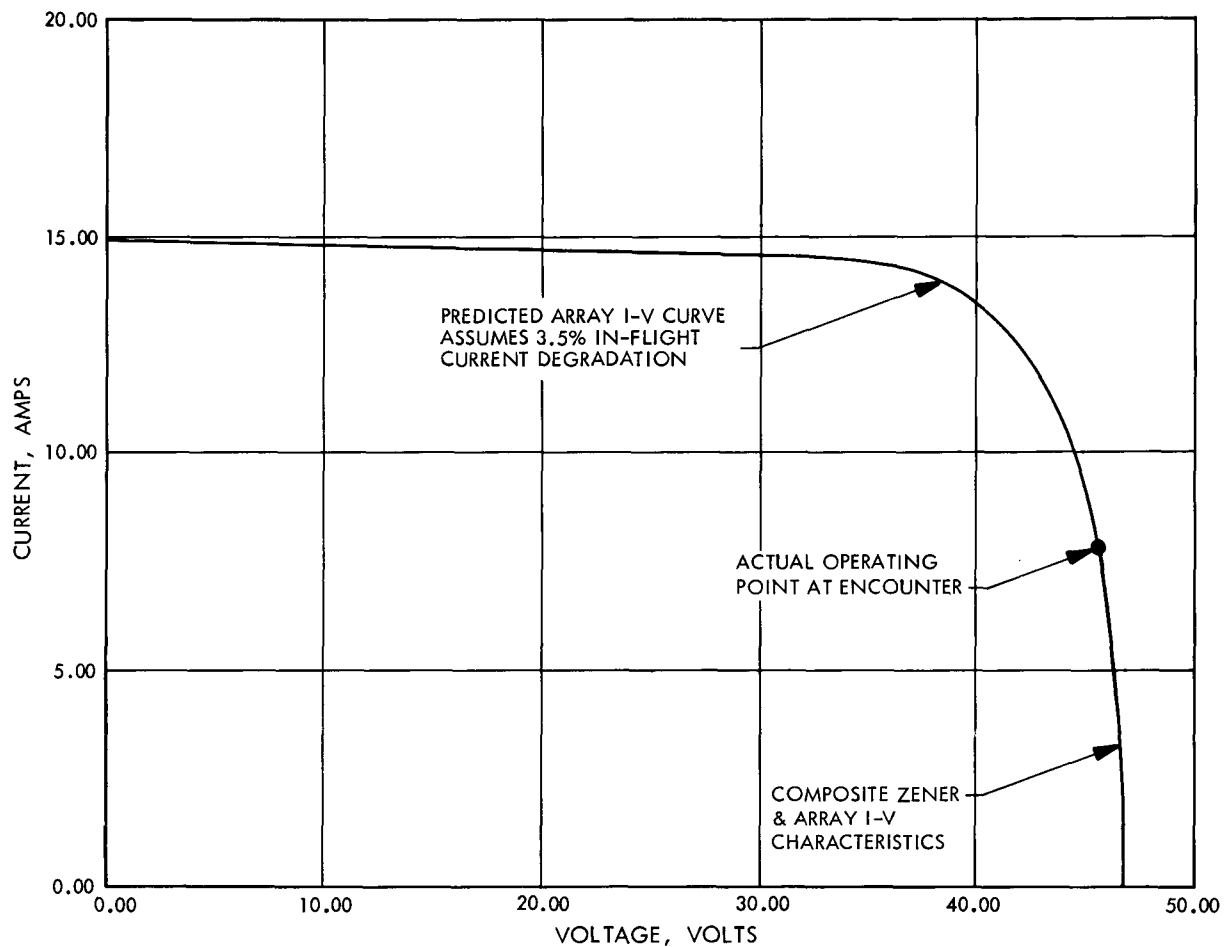
Fig. 19. Solar Array Predicted Performance at Encounter. Curve Degraded to Reflect Isc-Voc Transducer Telemetry Data (Prediction made 27 days before Encounter)

On November 14, 1971, the spacecraft was injected into orbit. The solar array current-voltage performance characteristics on November 14 are shown in Fig. 19. Solar array temperature was -2.3°C and the Sun intensity was 70.0 mW/cm^2 . The first orbit trim maneuver was successfully conducted on November 15, 1971. On December 30, a second orbit trim was made to correct the orbital period coordinating the periapsis timing with the view period of the antenna at the Goldstone tracking station in California. The maneuver also changed the periapsis altitude from 1387 to 1650 kilometers. The spacecraft remained in that orbit for the rest of its operational life. The estimated array output power performance at orbital apoapsis and periapsis for the 90-day standard

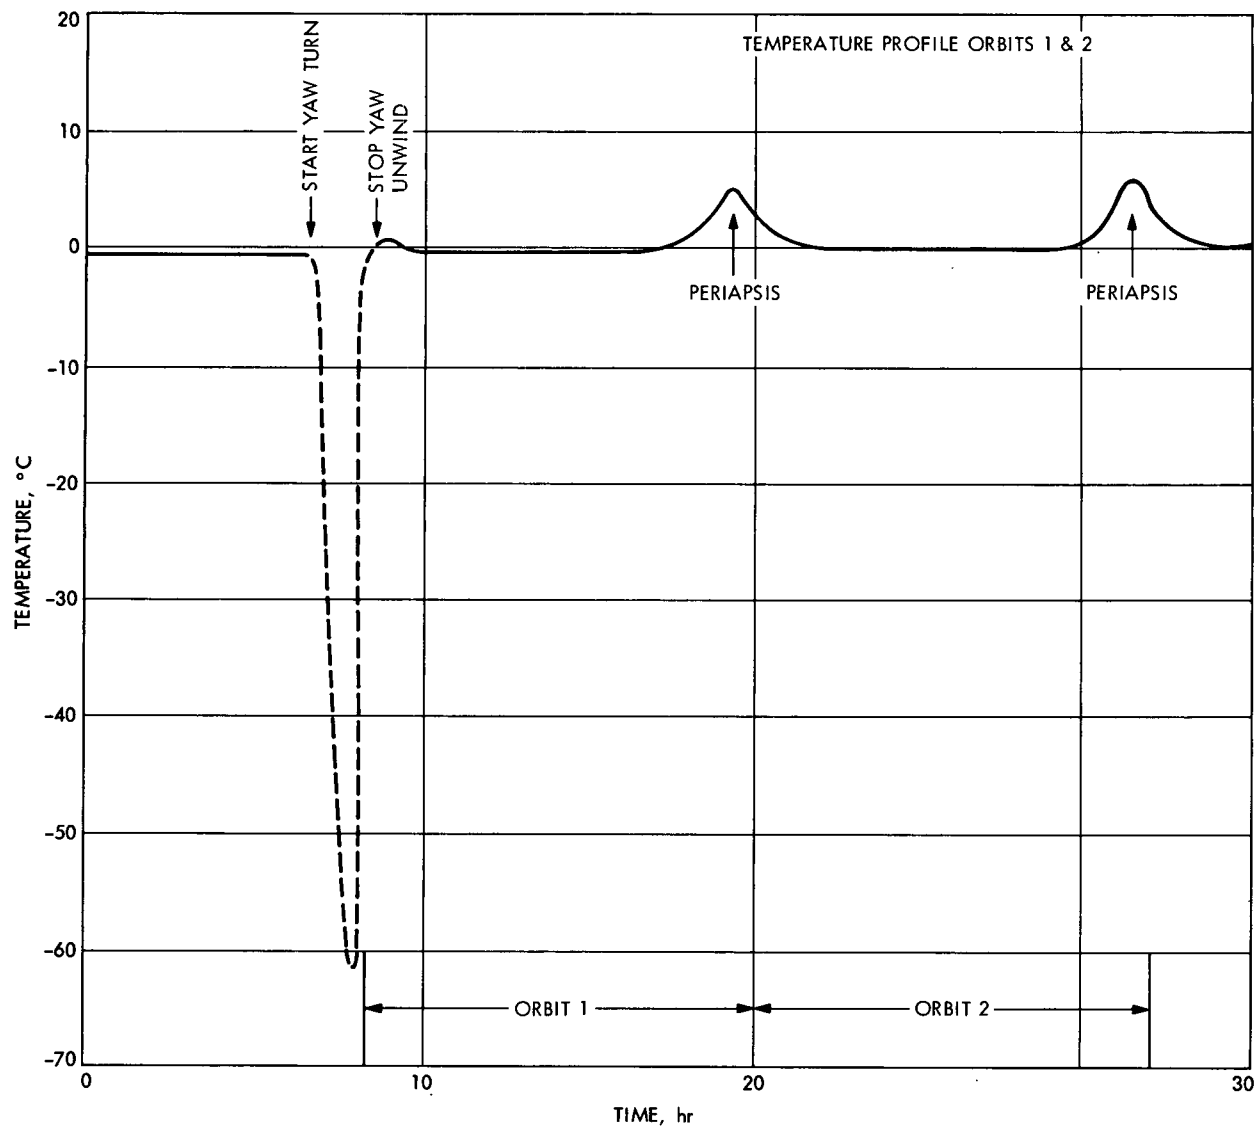
Fig. 22. Temperature Profile Orbits 1 and 2

mission is shown in Fig. 21. The solar array temperature profile for the initial mission orbits is shown in Fig. 22. The high array temperature is caused by planet albedo during the periapsis phase of the orbit point. The low array temperature at apoapsis was approximately at -2.2°C . At periapsis the array temperature is expected to rise to 5.6°C . This temperature profile continues to change as the planet moves further away from the Sun. The final orbit of the 90-day mission, orbit 180, is shown in Fig. 23 and indicates a low array temperature of -13.9°C , and rise to -1.1°C . Temperature telemetry data showed very good correlation with the temperature profiles indicated. During this orbital phase of the mission between April 2, 1972 and June 3, 1972, the spacecraft was subjected to 124 solar occultations created by the obscuration of the Sun by the planet. The longest of these occultations lasted 97 minutes and resulted in the array temperature decreasing to -158°C . As will be discussed later this occultation period occurred between the special array

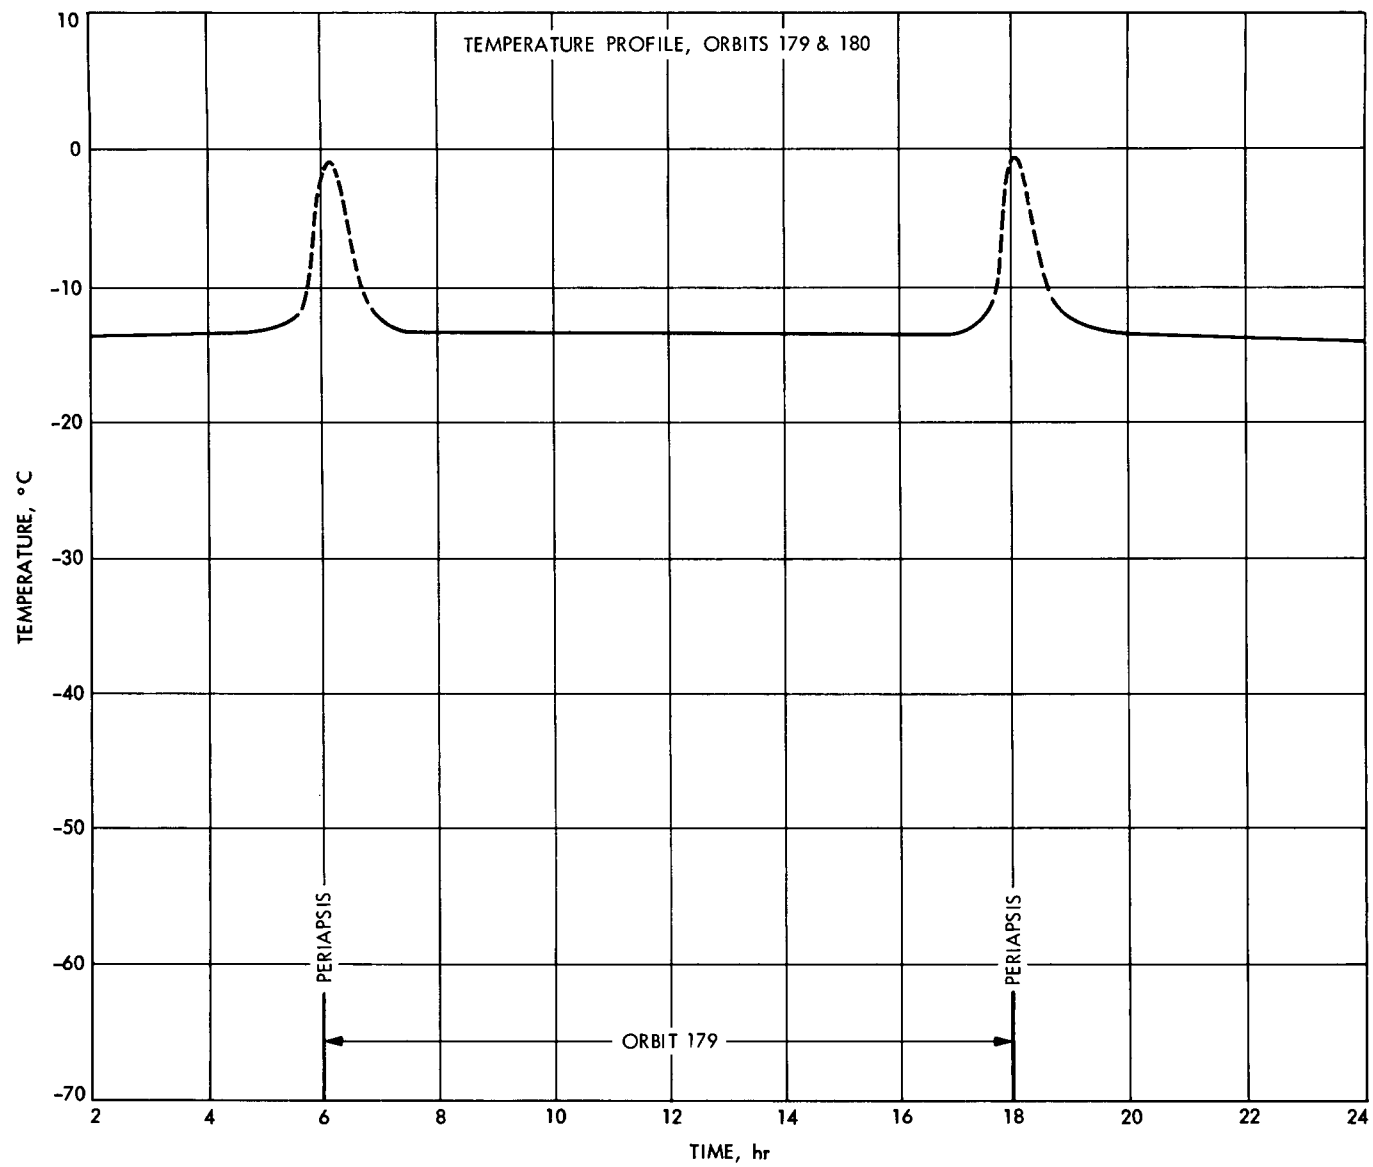
Fig. 23. Temperature Profile, Orbits 179 and 180

in-flight electrical test 2 and test 3. The tests indicated that no observable performance degradation resulted that could be attributed to thermal cycling. Later in the mission, starting on October 2, 1972 and lasting to mission termination on October 27, 1972, the spacecraft experienced 38 more occultations and hence thermal cycles. Although there was no detailed array performance measurement just prior to the end of the mission, it is not believed that these additional cycles did any damage to the solar array performance.

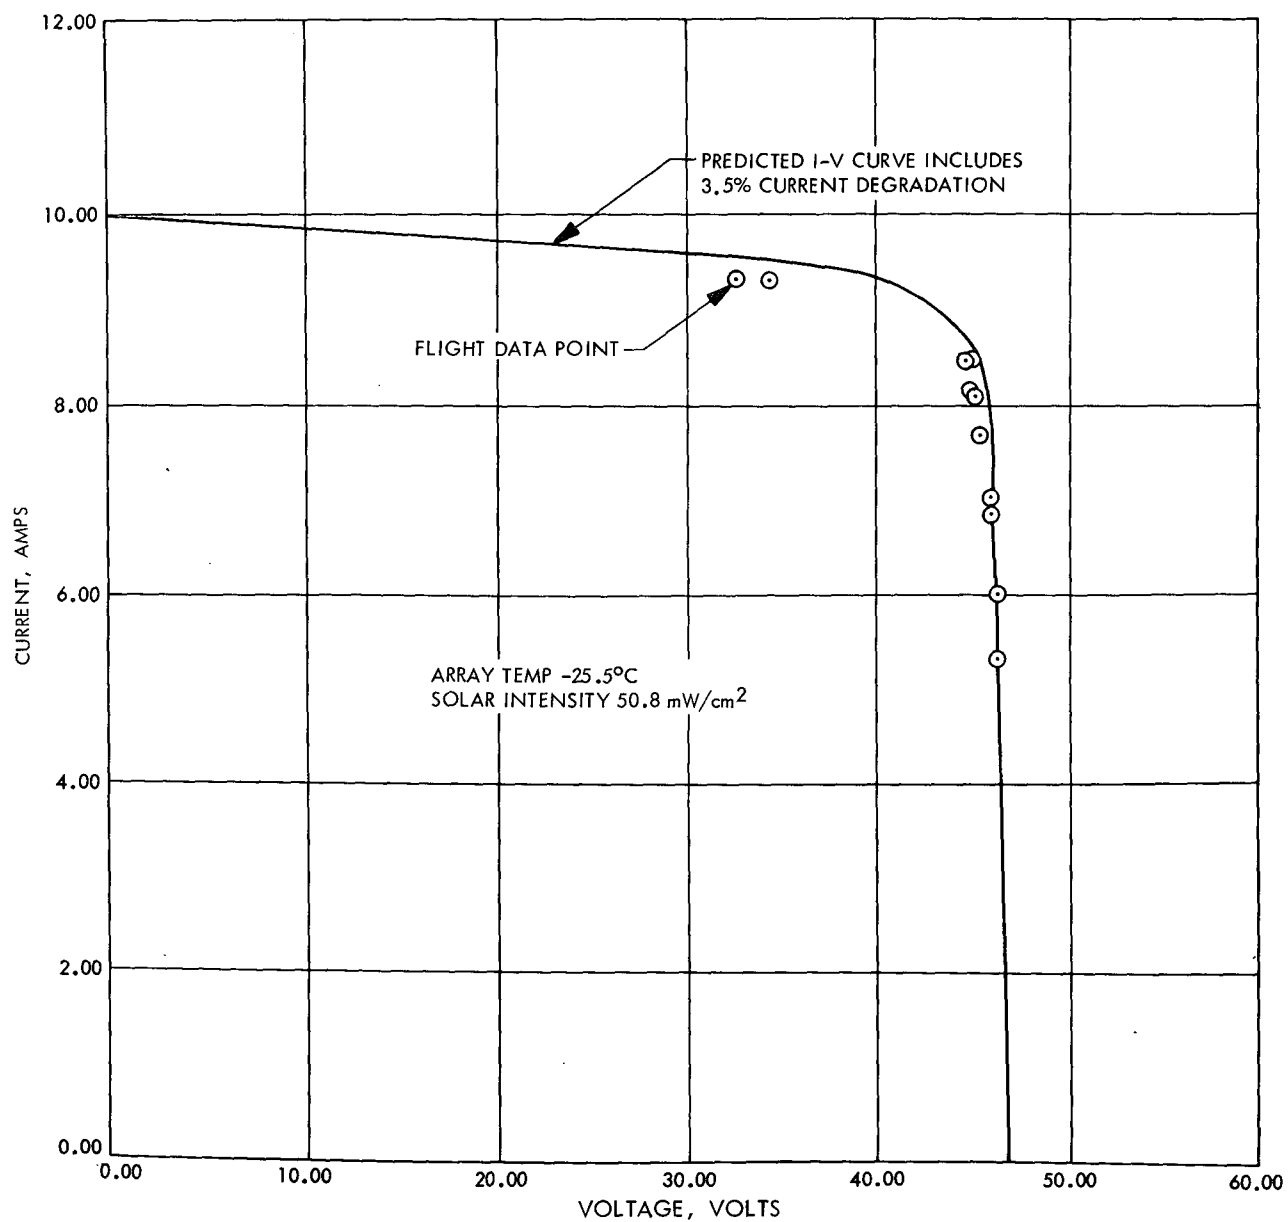
Fig. 34. Solar Array Performance During Test No. 4, October 2, 1972

The final special array test was conducted on October 2, 1972. The telemetry flight data as a function of time is shown in Fig. 32. Current-voltage points were selected to generate array I-V characteristics as shown in Fig. 33. The flight data in Fig. 33 were plotted on the predicted array performance curve as shown in Fig. 34. Again 3.5 percent current degradation factor was assumed from a study of the Isc-Voc transducer data. The resulting curve shows good agreement with the flight data.
